# Evaluation of Multilayer Printed Wiring Boards by Metallographic Techniques

*An Illustrated Guide to the  
Preparation and Inspection  
of Plated-Through Hole  
Test Coupons Based on the  
Requirements of MIL-P-55110D*

**NASA  
Reference  
Publication  
1161**

**Evaluation of Multilayer  
Printed Wiring Boards by  
Metallographic Techniques**

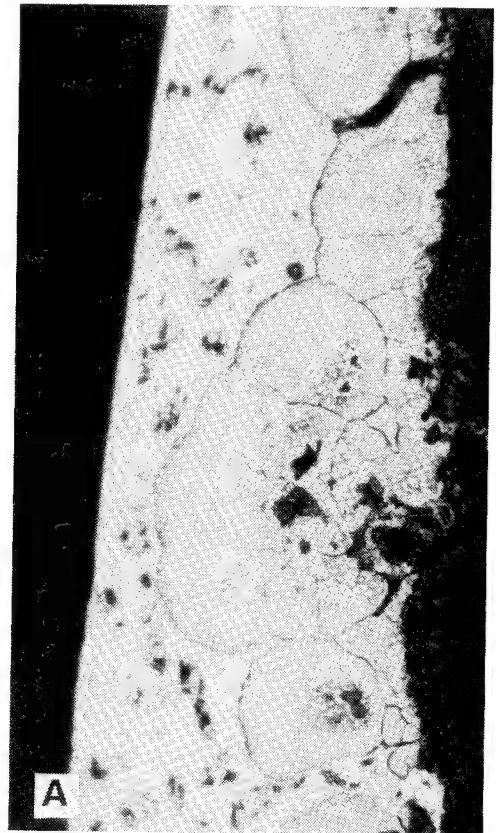
Figure 9. Examples of plating nodules in barrel plating.

- A. NODULES ASSOCIATED WITH BRITTLE PLATING PROBABLY RESULT FROM PLATING BATH COMPOSITION PROBLEMS. THE NODULES WOULD BE ACCEPTABLE; THE CRACKS ARE NOT. ETCHED, 500X.
- B. NODULES IN ONE PLATING LAYER ON ONE SIDE OF THE BOARD MAY RESULT FROM IMPROPER POSITIONING OF ELECTRODES DURING PLATING. ETCHED, 50 X.
- C. HIGHER MAGNIFICATION VIEW OF HOLE ILLUSTRATED IN B. ETCHED, 175 X.

Nodules, plating folds, and glass fiber protrusion are signs of sloppy drilling or hole cleaning prior to plating, and can lead to plating cracks under thermally induced stressing. Nodules may result from plating over an irregular hole surface or may be a sign of a plating bath going out of control. Plating bath composition and operating parameters such as temperature, current density, time in bath, and the physical arrangement of the workpieces in the plating tank all contribute to the quality of the final plating, and should all be closely monitored on a regular schedule. The nodules in Figure 9a are associated with brittle, columnar microstructure which has cracked under thermal stress. Those in Figure 9b and 9c are confined to one surface of the board and probably reflect improper positioning of the electrodes in the plating tank. The nodules in Figure 10 arose when the plating attempted to coat an irregular hole surface which had numerous epoxy lumps which were not removed during the hole cleaning process. Note that the hole illustrated in Figure 9b should also be checked for layer-to-layer registration. It is not infrequent that more than one defect is found on a poorly fabricated board.

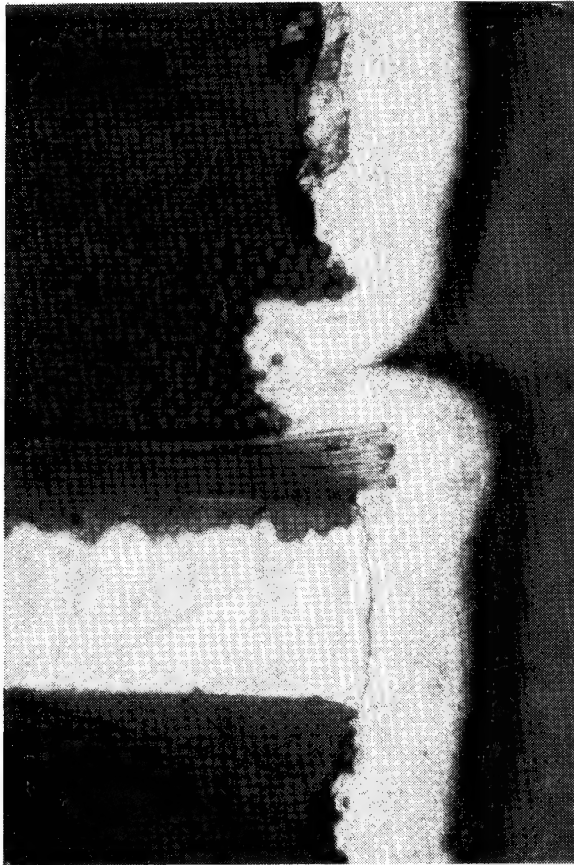
Figure 11. Plating folds resulting from irregular hole wall surface. Plating in right hand photo has columnar microstructure and should be carefully examined for cracks, particularly after solder float testing. The folds are acceptable. Etched, 400X.

Figure 11 illustrates plating folds. The initial electrolytic copper plating layer followed and adhered to the irregular surface of the hole wall, and the subsequent buildup of electrolytic copper resulted in a folded structure. These sharp folds have high stress concentration factors, and cracks may initiate at these locations. Coupons exhibiting this condition should be carefully checked for cracked plating after solder float testing. Glass fiber protrusion into brittle and/or thin plating may also lead to cracked barrel plating, Figure 12. Plating folds, nodules, and glass fiber protrusion which project into the hole, Figure 13, are acceptable provided the hole diameter is not reduced below what is specified on the master drawing. Since this drawing is not generally available to the metallographer, the presence of nodules, folds, and protrusion

should be noted, and the minimum remaining hole diameter should be measured and stated in the evaluation report.

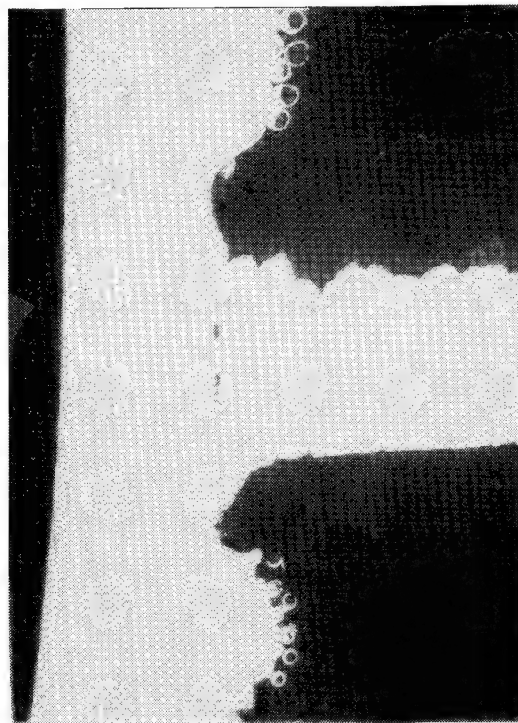
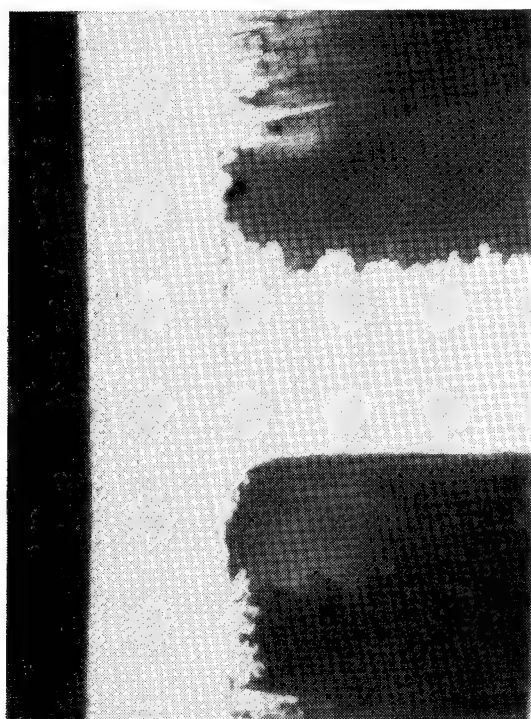
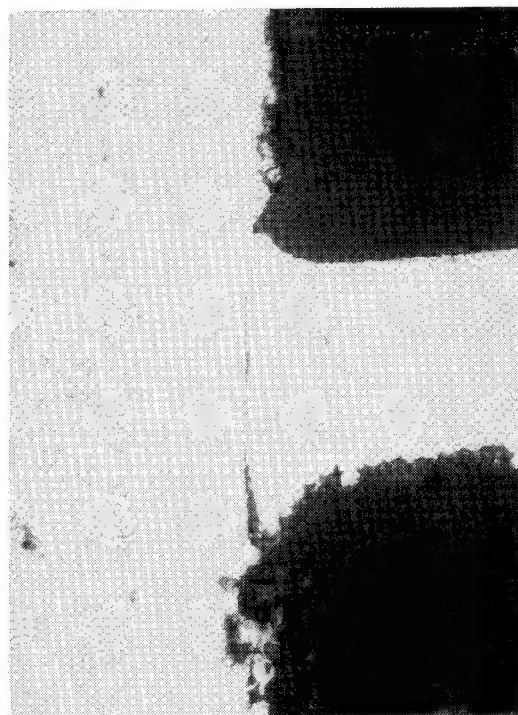
**GOOD: NO VISIBLE DEFECTS**

**MARGINAL (?) ~ 10% DEFECTIVE**

**MODERATELY SEVERE: 10 – 50% DEFECTIVE**

**SEVERE: > 50% DEFECTIVE**

Figure 36. Examples of defect levels at barrel/innerplane junctions. All unetched, at 400X.

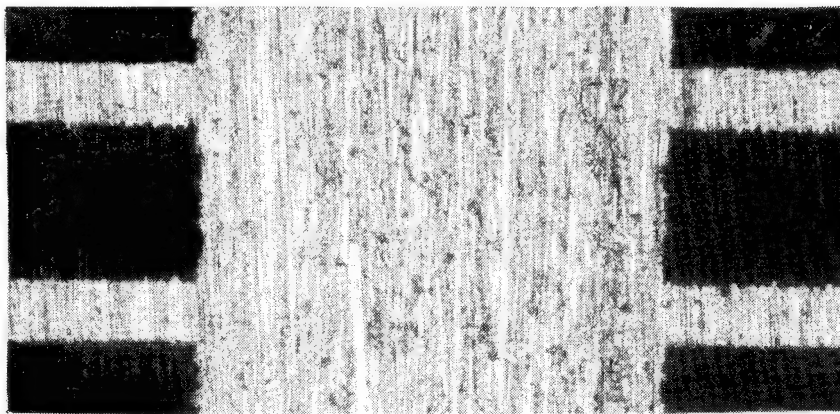
**1 MICRON ALUMINA  
FINISH**

Figure 39. Typical appearance of specimen at various stages of preparation. All at 75X.

ish can only be worked out by experience. Specimens should be checked at 50 — 100X after each polishing step to ensure that the effects of the prior step have been completely removed. Figure 39 illustrates the typical appearance of specimens after 600 grit, 1.0, 0.3 and 0.05 micron alumina steps.
